Laboratoires Quinton International, S.L.
CERTIFICATE OF ANALYSIS

Microplastic analysis in sea water

GENERAL DATA	
PRODUCT DENOMINATION:	SEA WATER
PRODUCT DESCRIPTION:	RAW MATERIAL
BATCH:	MP-1-167 4474335
REFERENCIA DOC:	DOC LQI-LBQ 4474335 MP-1-167

ANALYTICAL REPORT: MICROPLASTIC ANALYSIS IN SEA WATER

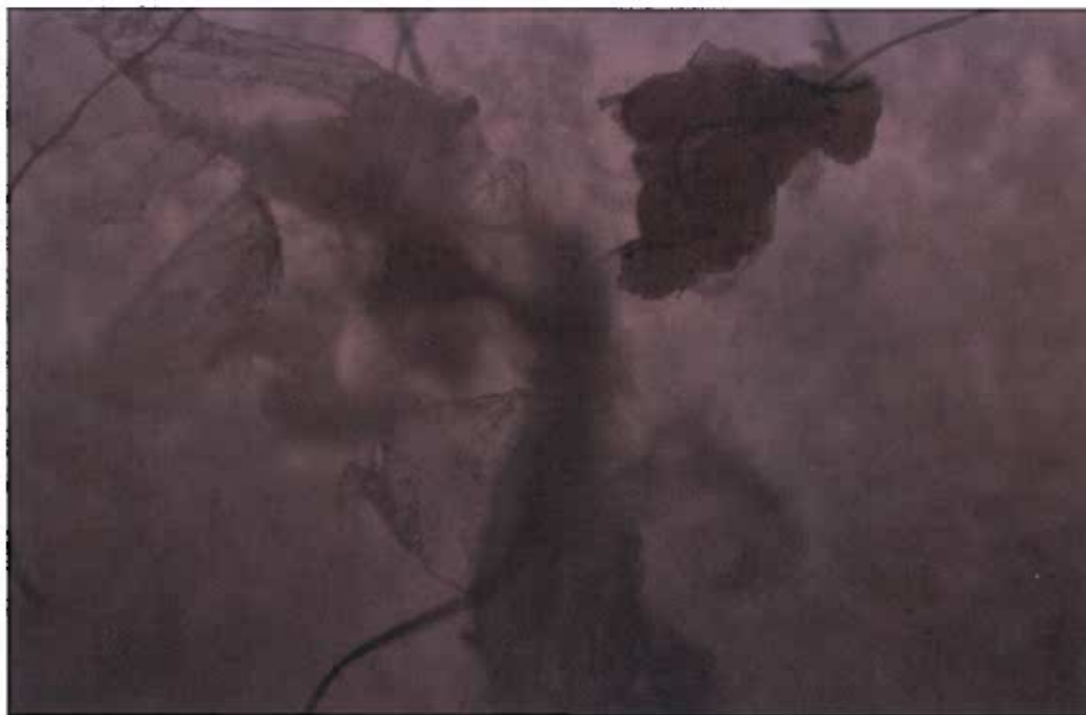
Figure 2. Image of the standard.

To ensure the analytical process, a standard with various kinds of microplastics was also analyzed. The figure 2 show an image of QC sample by microscopy.
